**SUBJECT: FINAL RCRA CORRECTIVE ACTION SITE VISIT REPORT
USACE CONTRACT NO. W912DQ-08-D-0019
TASK ORDER NO. 005A**

FINAL RCRA SITE VISIT REPORT

**Maryland Environmental Services Hawkins Point Controlled
Hazardous Substance Landfill
EPA ID No. MDD 000 731 356
5501 Quarantine Road
Baltimore, MD 21226**

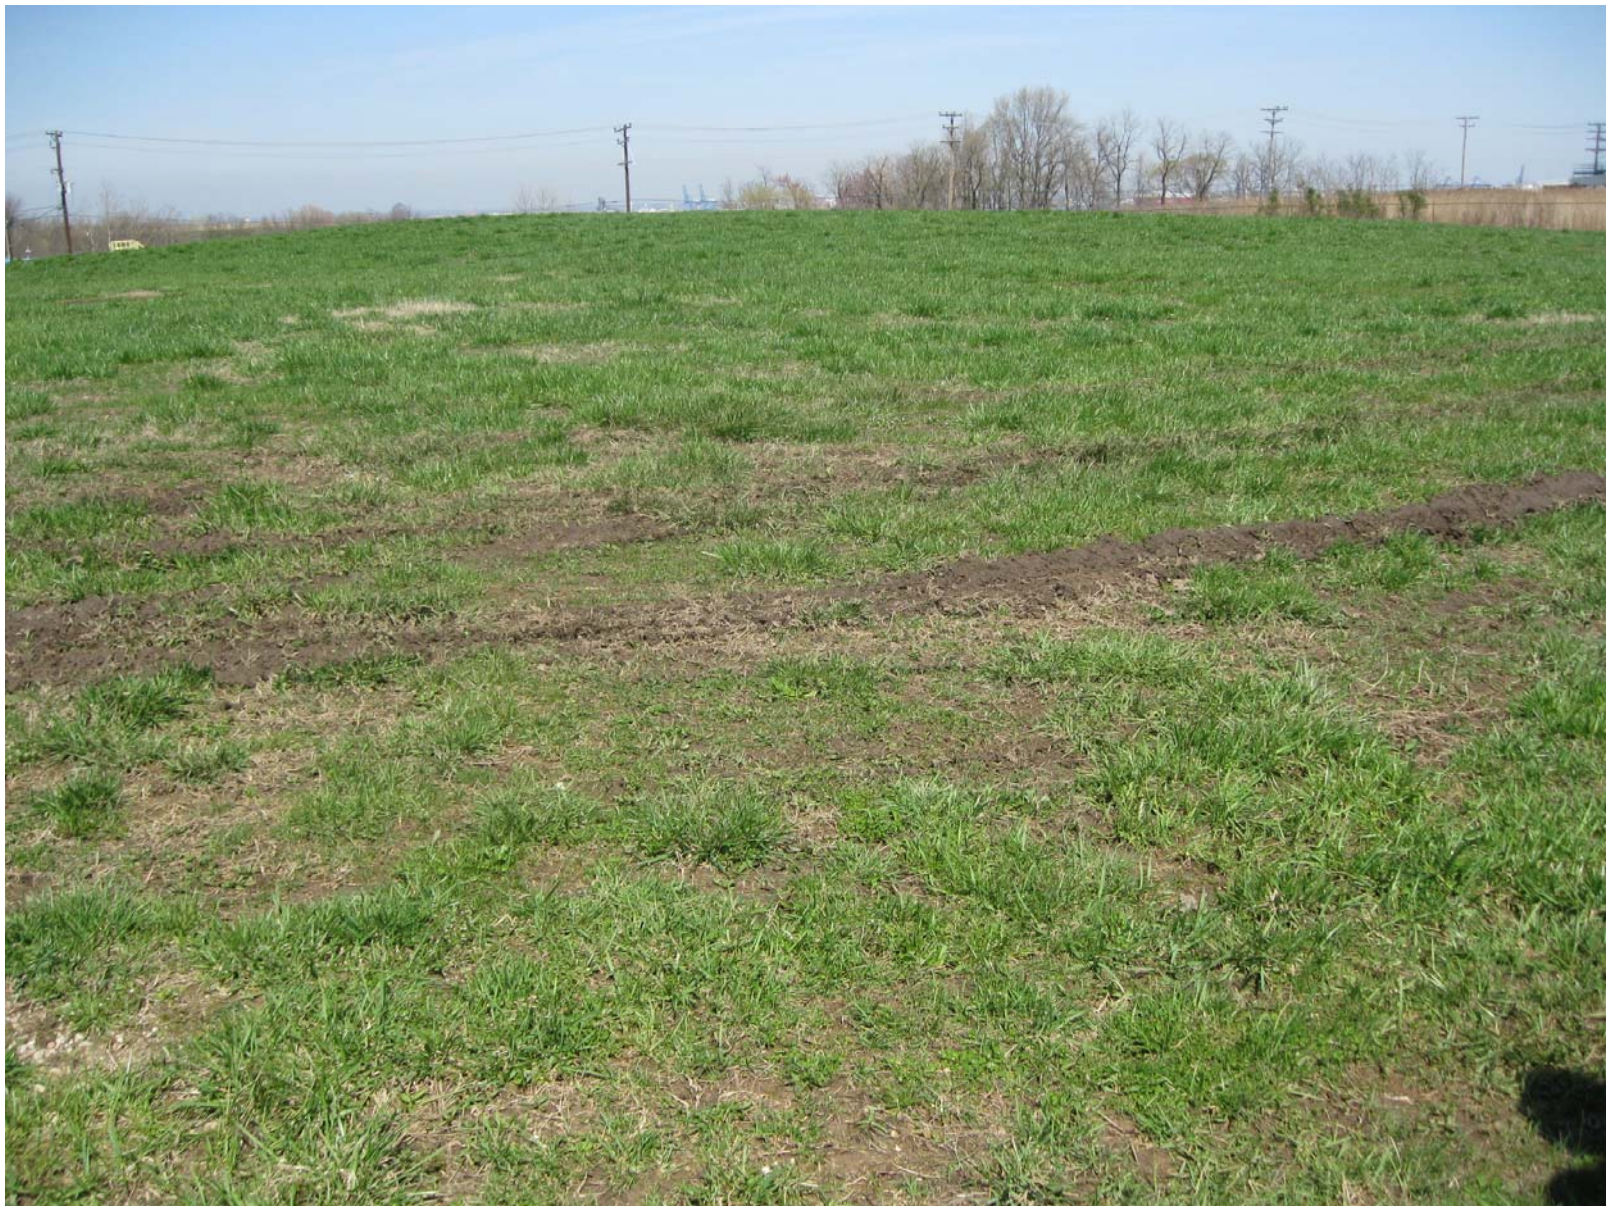
Photograph 1: SWMU No. 2 – Area 2

From 1975 to 1979, COPR materials were disposed of in three clay-lined cells located in Areas 2 and 3. Areas 2 and 3 contain COPR cells constructed by MPA which are managed by MES. Leachate generated from Areas 2 and 3 is managed by a leachate collection system constructed in the late 1970s and rehabilitated in 2002. The collected leachate is conveyed to an in-ground wet well and an above-ground storage tank respectively before being transported off-site by tanker truck for disposal at a permitted facility.

MES performs environmental compliance groundwater monitoring using perimeter wells installed in Areas 2 and 3, and manages overland surface water flow with a surface water collection swale. This non-impacted surface water is discharged to Thomas Cove.

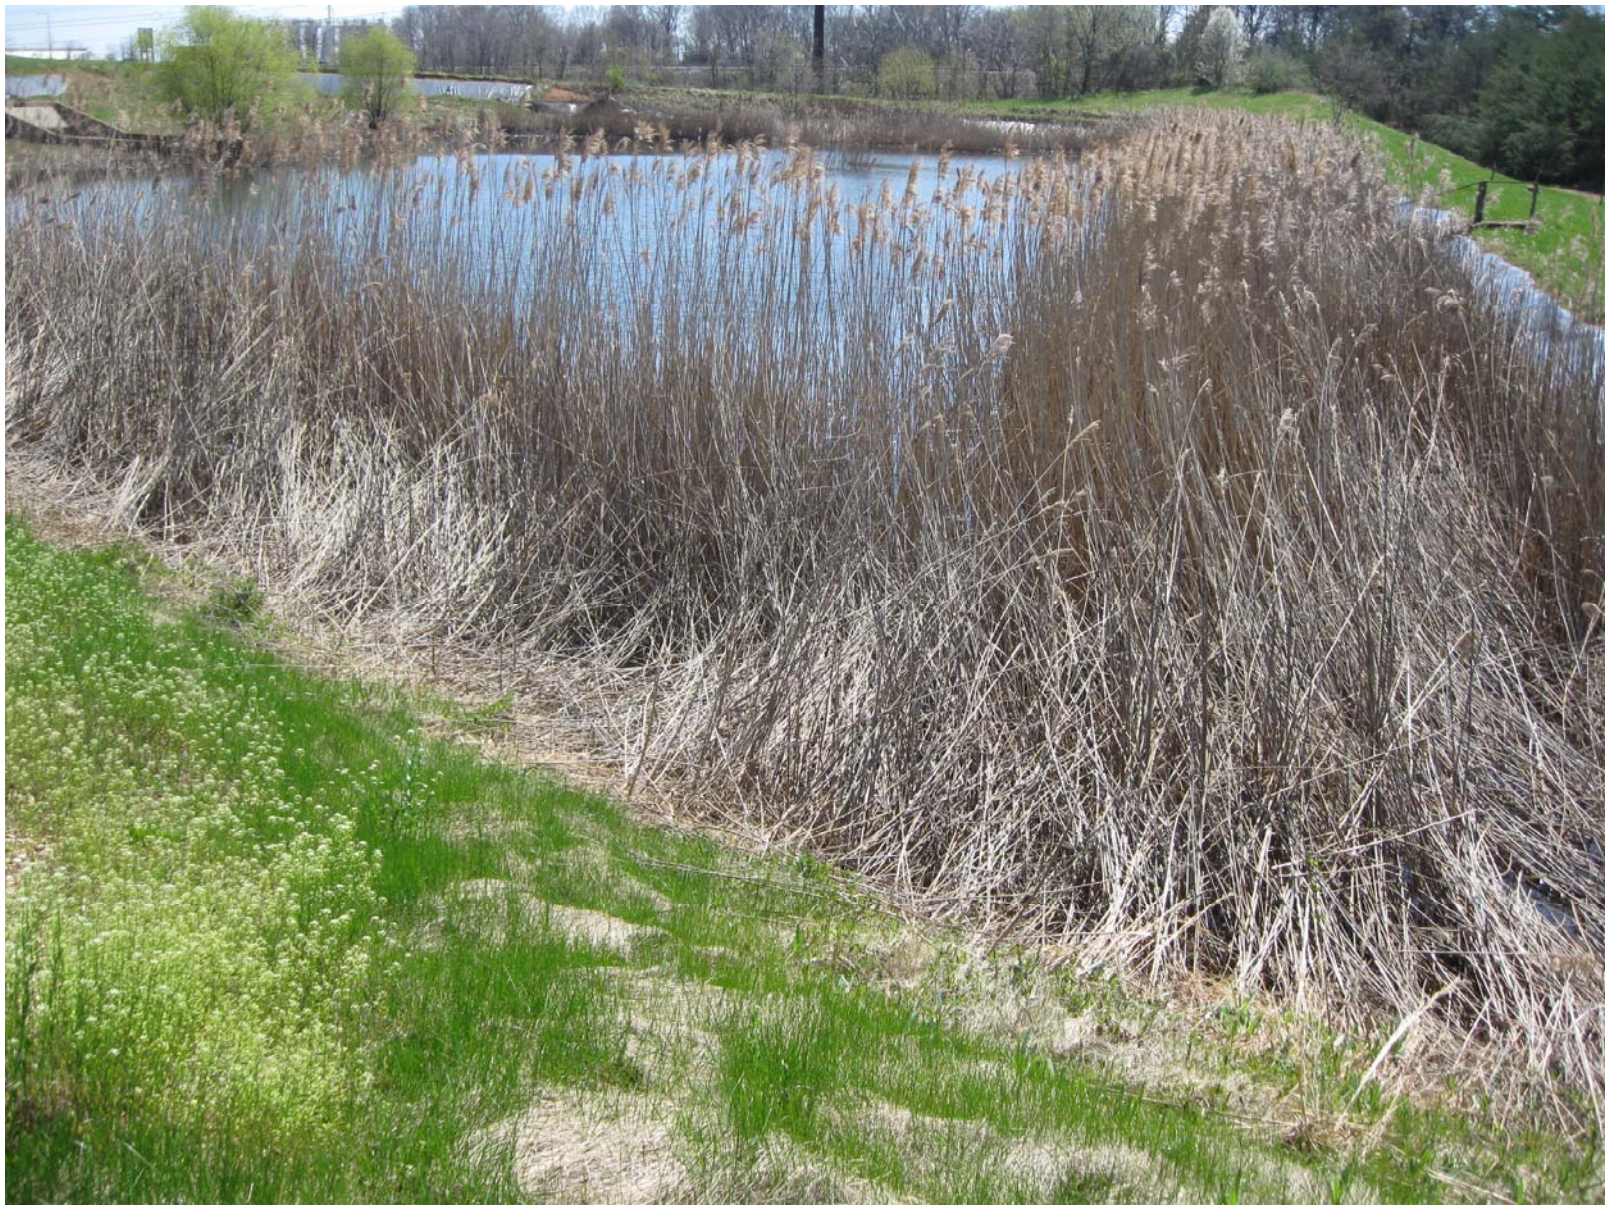
Photograph 3: SWMU No. 3 – Area 3/Cell 40

During January 1983, Cell 40 located within the Area 3 disposal cell, received COPR. The cell was operated by MES for a short period of time and due to economic reasons was then closed. COPR materials placed within Cell 40 were removed and transported to Fondessy, Ohio for disposal at a permitted facility. Cell 40 has not been used for material disposal since it was taken out-of-service. The 80-mil HDPE liner remains in-place and Cell 40 requires periodic dewatering by MES to remove uncontaminated rainwater which accumulates within the cell. SWMU Nos. 2 and 3 are shown in Photographs 2, 3, and 4 in Appendix A at the time of the 2010 RCRA Site Visit.

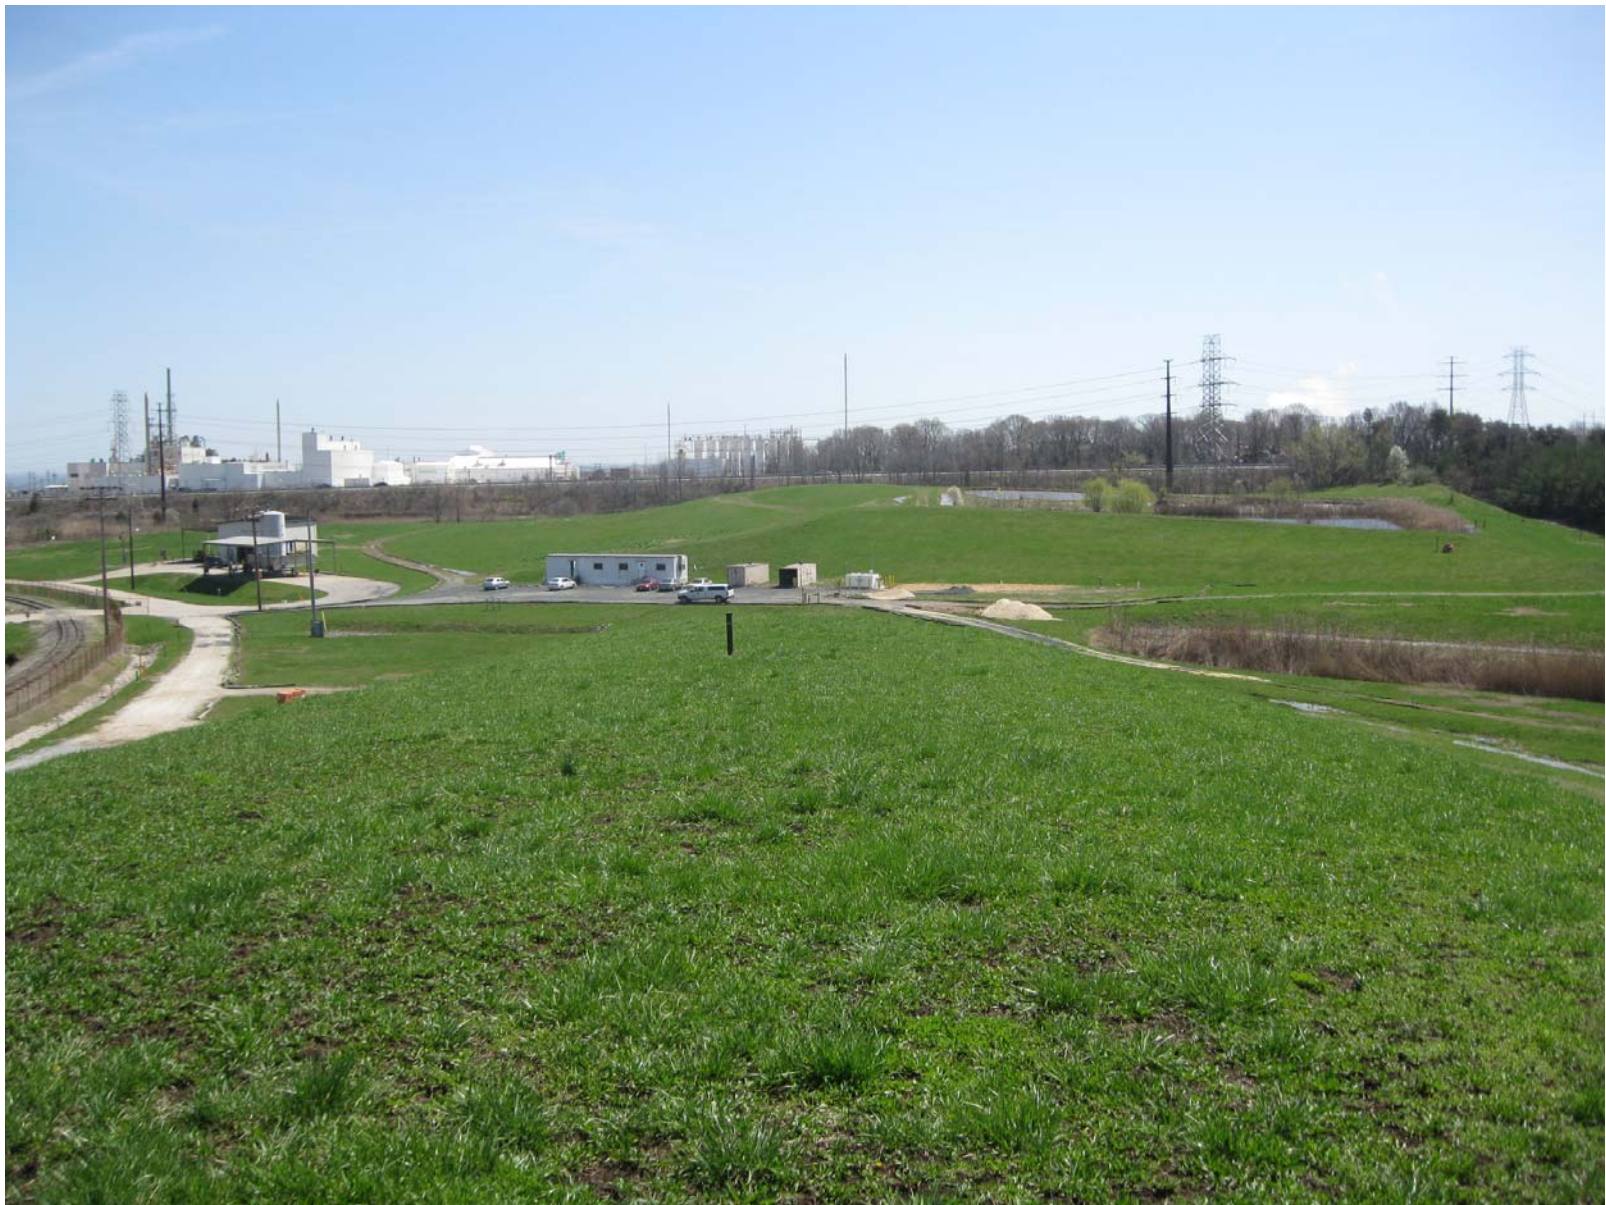
Photograph 4: SWMU No. 1 (not pictured, left of Photograph) – Area 1

SWMU No. 2 (center) – Area 2

SWMU No. 3 (right) – Area 3

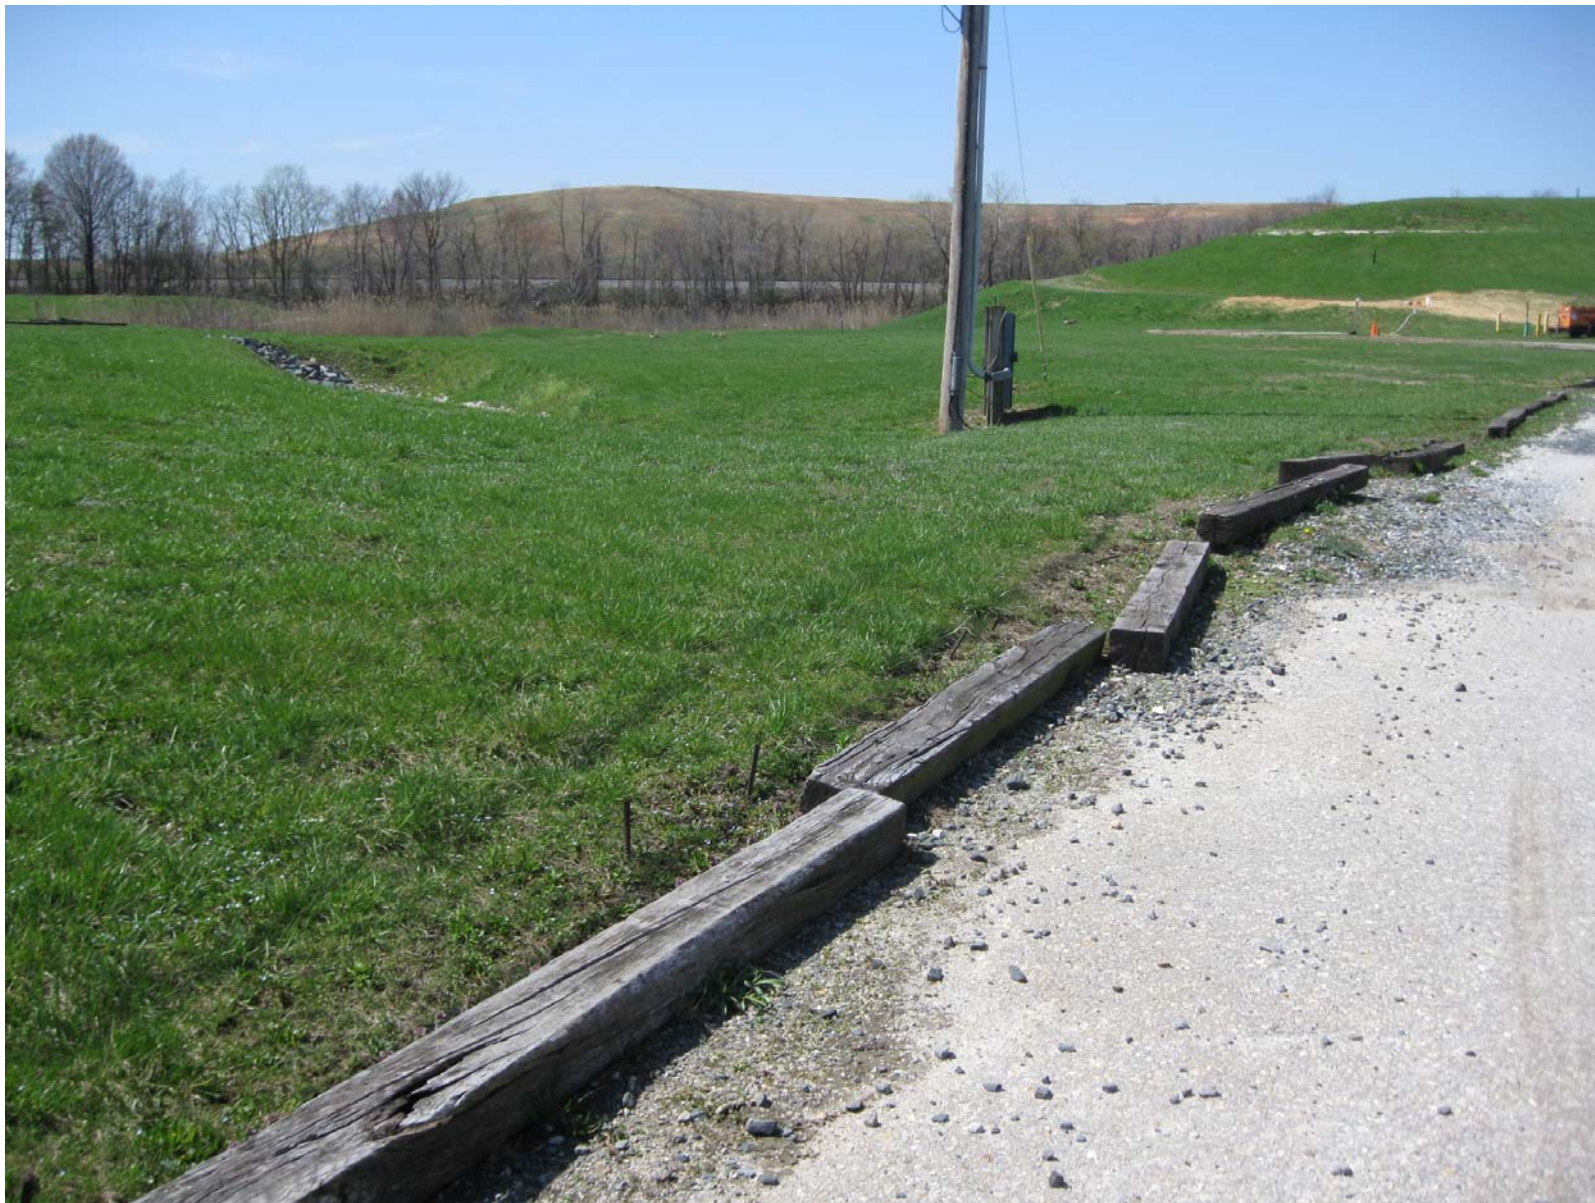
Photograph 5: SWMU No. 4 – Area 4

Area 4 contained two temporary leachate holding lagoons during construction of Area 5. These temporary lagoons were lined basins used for storage of surface water collected during landfill construction. They were removed when landfill construction was completed in 1993.

Area 4 has also been identified as a location where a “paint sludge” material was reportedly observed in a June 27, 1985 Assessment of Continuing Releases Report. This sludge storage area pre-dates landfill closure and there is no documentation indicating the status of the paint sludge. SWMU No. 4 is shown in Photograph 5 in Appendix A at the time of the 2010 RCRA Site Visit.

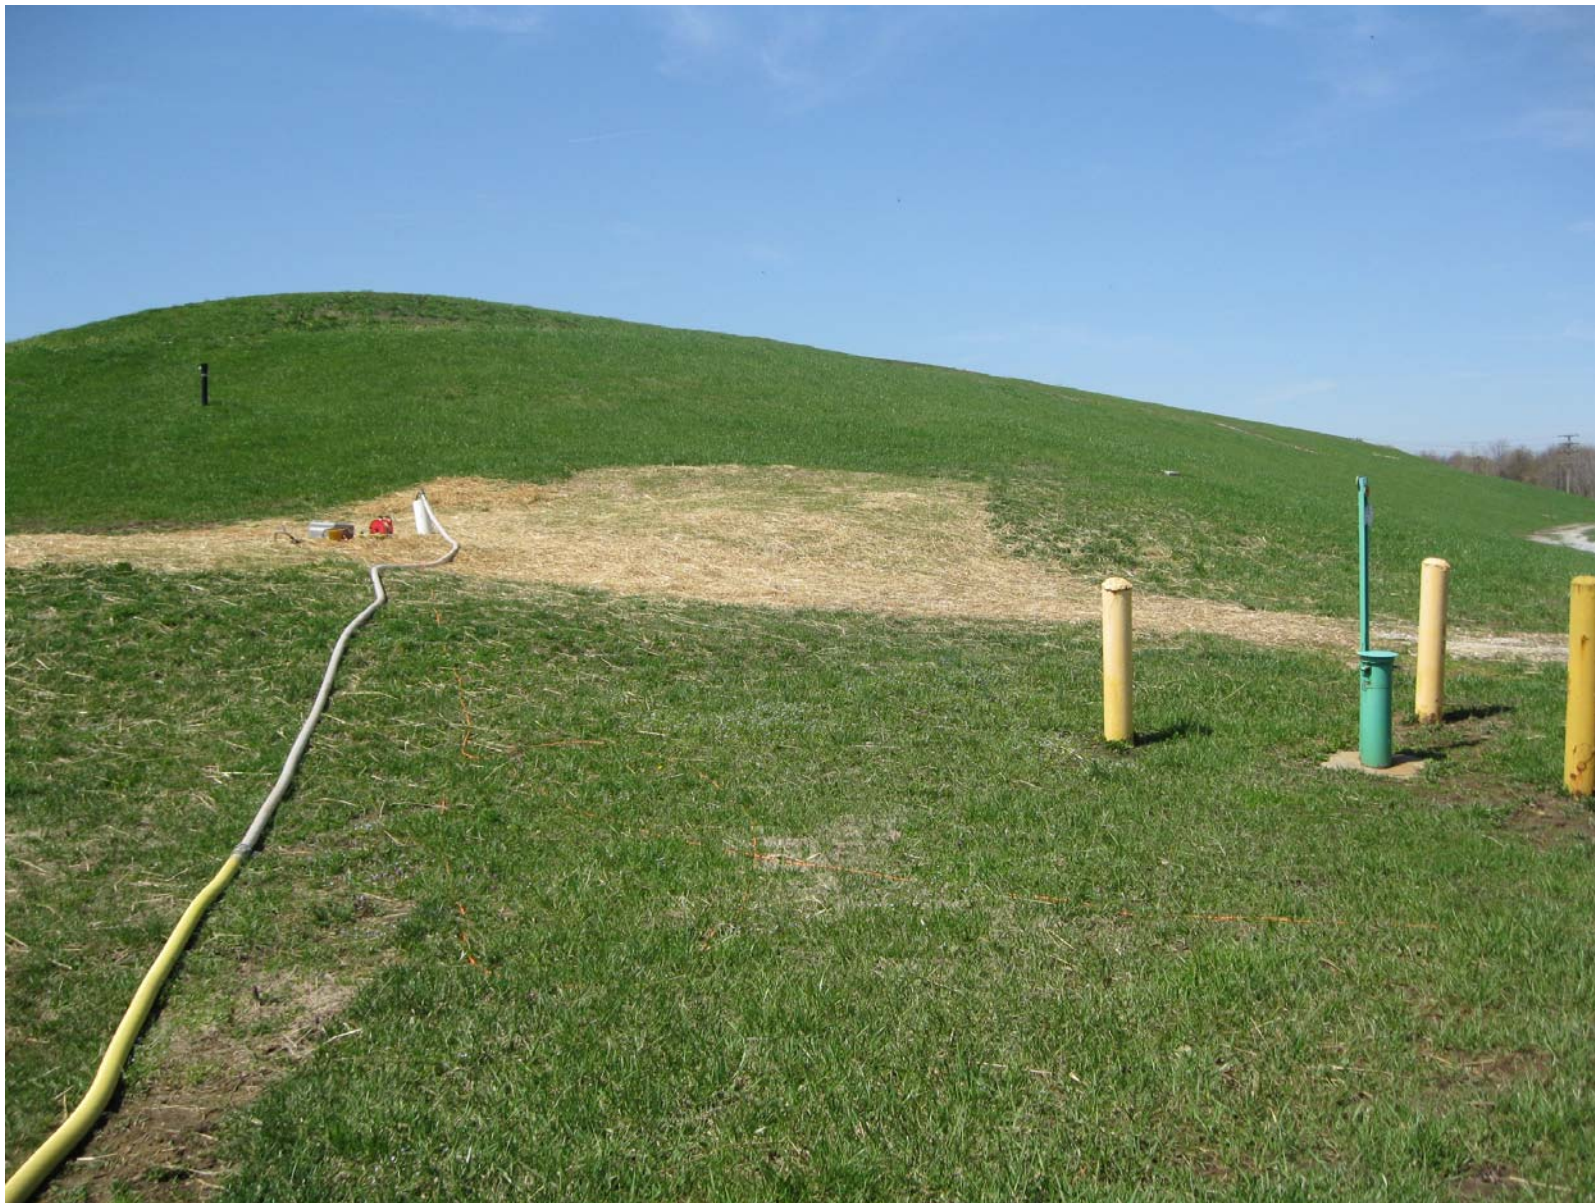
Photograph 6: SWMU No. 5 – Area 5

Area 5 was used for the disposal of COPR and demolition debris from AlliedSignal, Inc. (now Honeywell). Area 5 is comprised of 10 waste cells (numbered 1-3, and 5-11, there is no cell 4) containing COPR and chromium contaminated soil, trash, construction debris from demolition of the former AlliedSignal Corporation, Baltimore Works Plant.

In March 2003, a seep was discovered at the southeastern corner of Area 5. As a result, in December 2005, an in-ground trench drain was installed to intercept the seep flow and it was conveyed to the Area 5 existing leachate collection system. In 2008, a seep was identified near

the interceptor drain, which consisted of moisture being present in a small area at the ground surface. Measures have been taken to optimize operation (line cleaning) of the interceptor trench drain.

MES is permitted to store and treat chromium containing leachate in the aboveground storage tank, and installed a treatment system in 1999 that was operated on a pilot basis for a one year period. This system was removed from service because treatment of the leachate did not consistently achieve chromium reduction required to meet effluent discharge limitations. There are no plans to return the treatment system into service. SWMU No. 5 is shown in Photograph 6 in Appendix A at the time of the 2010 RCRA Site Visit.

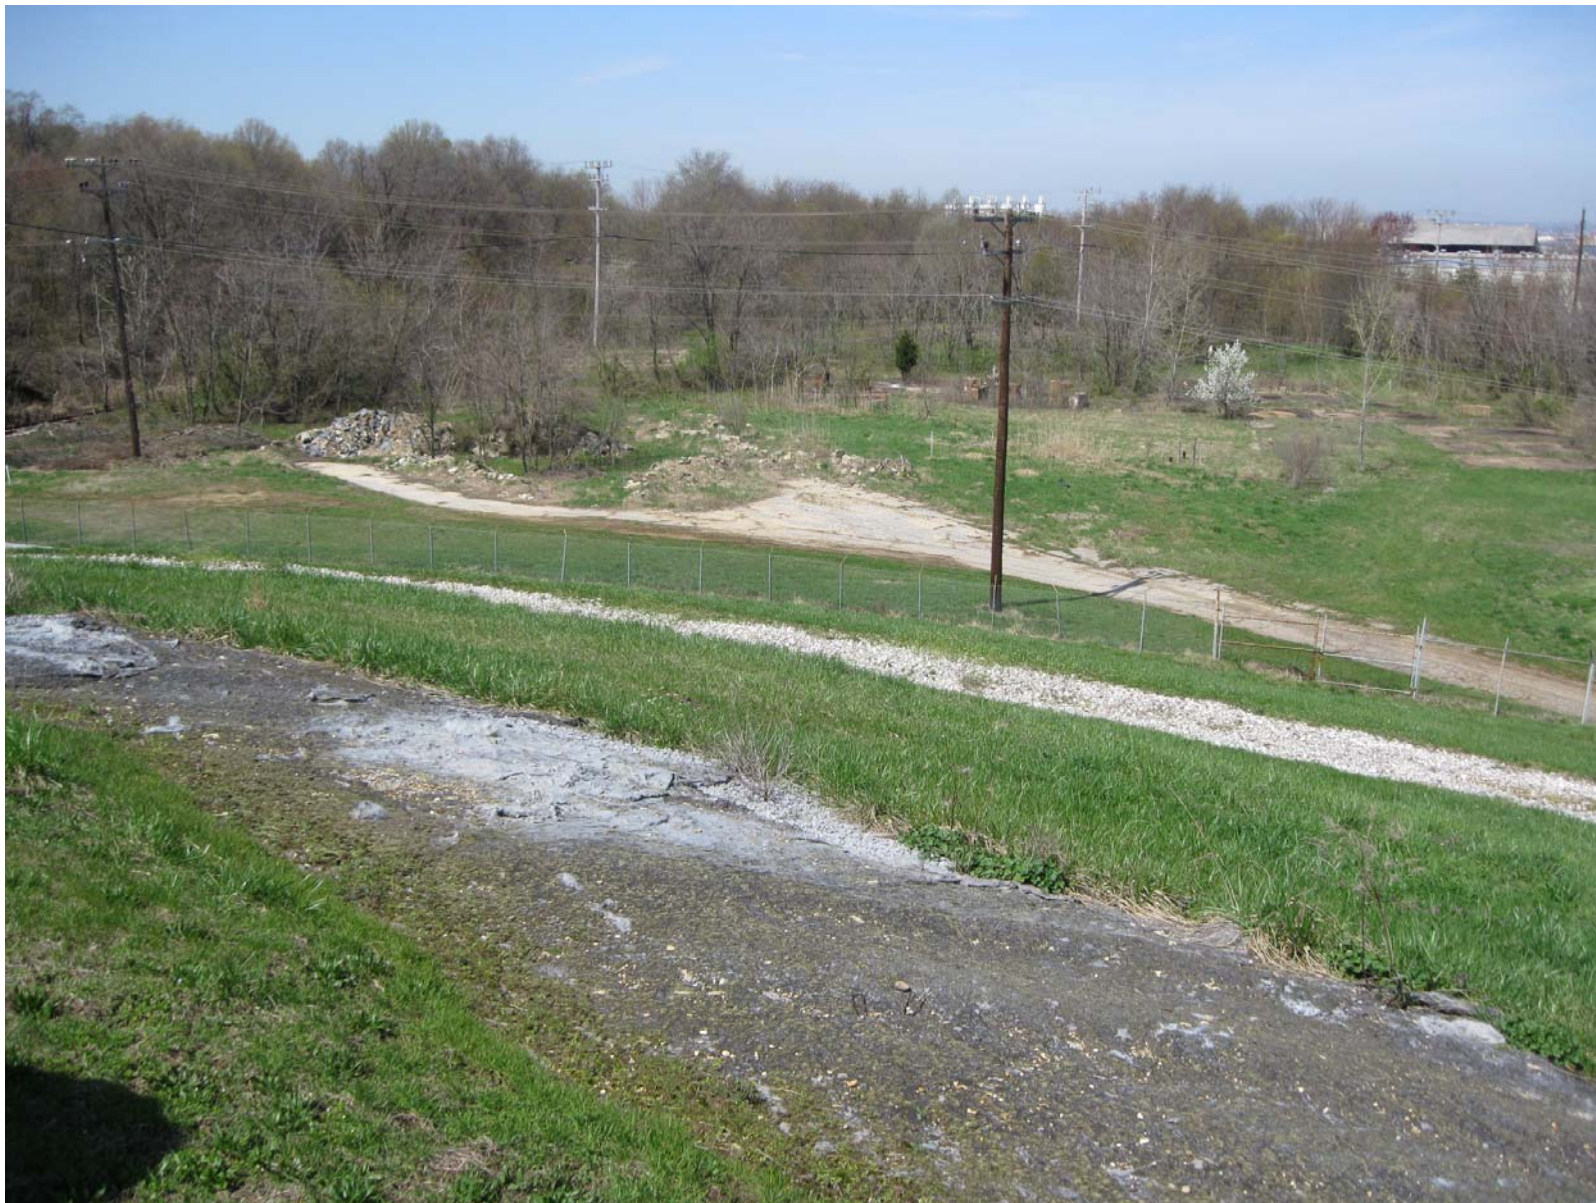
Photograph 7: SWMU No. 6 – Area 6

Area 6 was used for short-term storage of containerized ferrous sulfate by MES before being transported to other facilities.

Additionally, a small-scale, limited duration pilot test for solid waste treatment was performed in Area 6 circa 1996. The pilot testing was performed within a contained area which was removed following the completion of the pilot testing activities. SWMU No. 6 is shown in Photograph 7 in Appendix A at the time of the 2010 RCRA Site Visit.

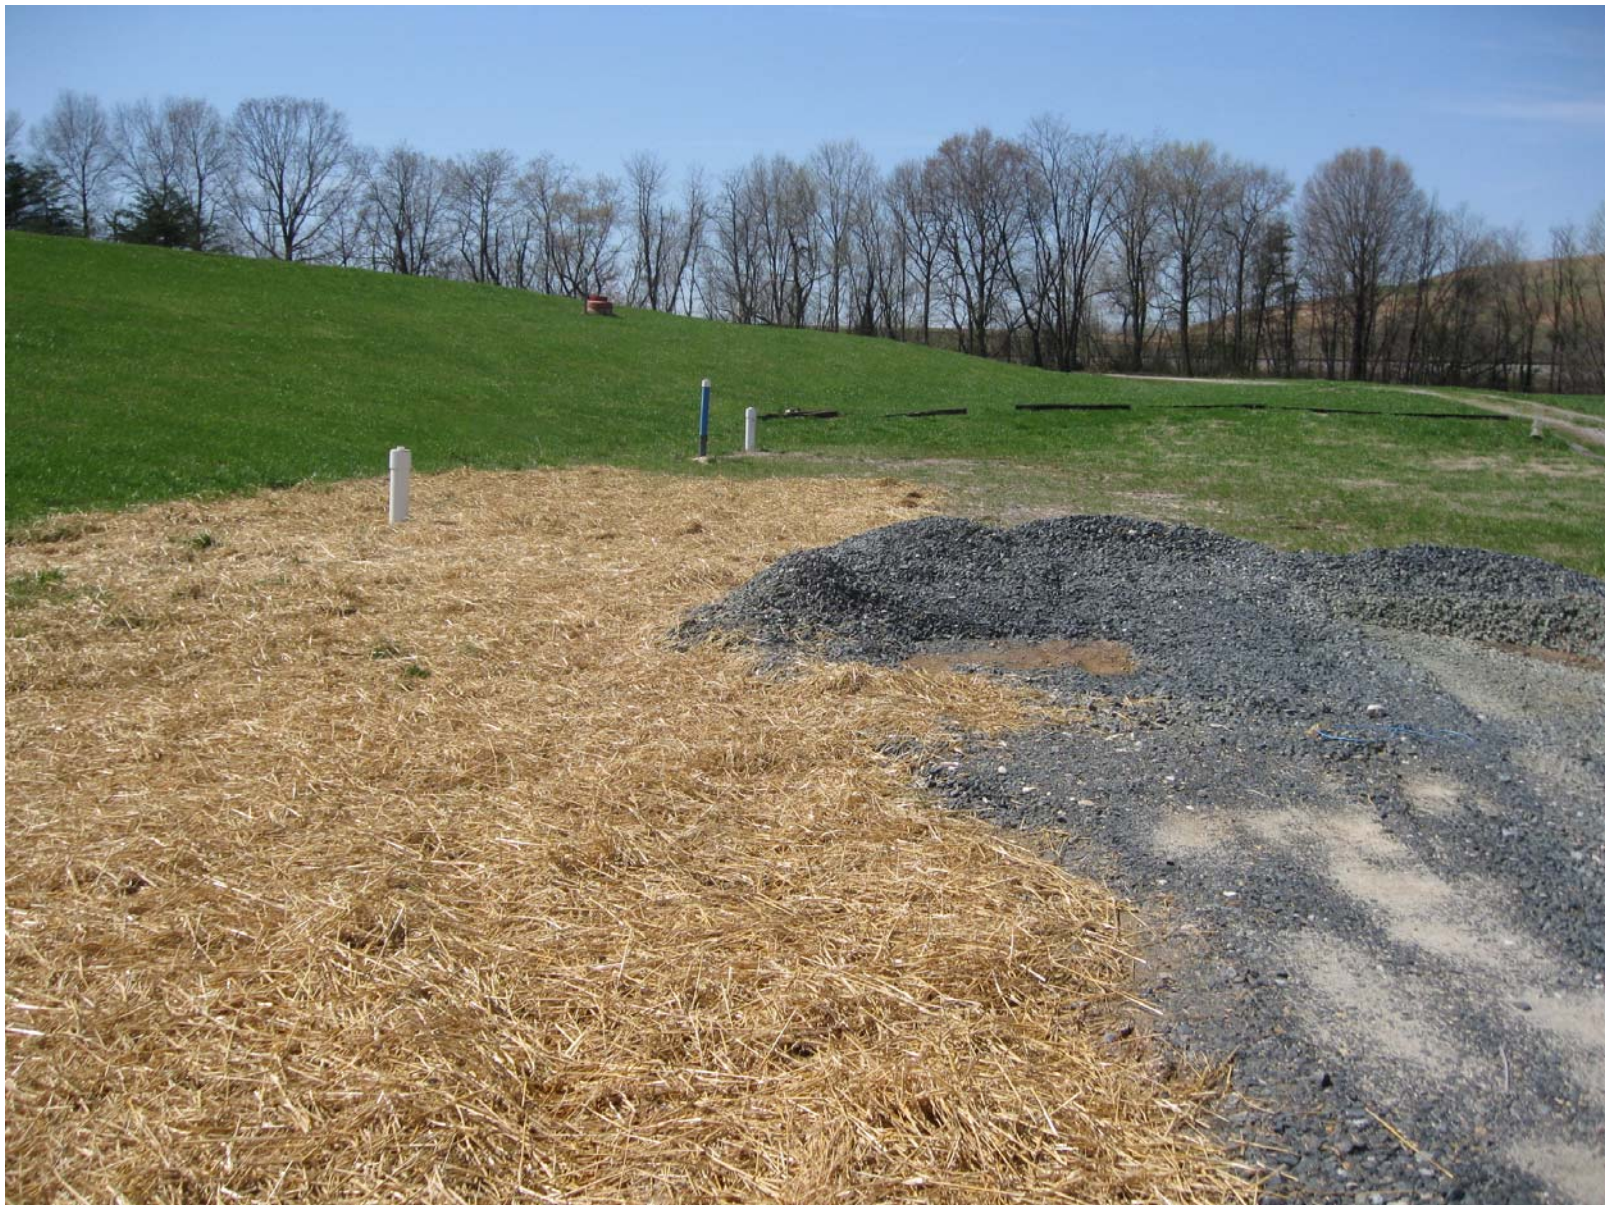
Photograph 8: SWMU No. 7 – Septic Tanks

The facility's septic system receives sanitary wastewater from drains and toilets. The system consists of two 5,000 gallon holding tanks, with a total capacity of 10,000 gallons. The holding tanks are installed belowground and receive sanitary wastewater via conveyance line from the on-site trailer.

According to site representatives, a past leak allowed surface water to enter one of the septic tanks. However, it is reported that no wastewater overflowed the tank and the septic tank was repaired. No documentation regarding this septic tank repair was prepared as a release did not

occur. SWMU No. 7 is shown in Photograph 8 in Appendix A at the time of the 2010 RCRA Site Visit.

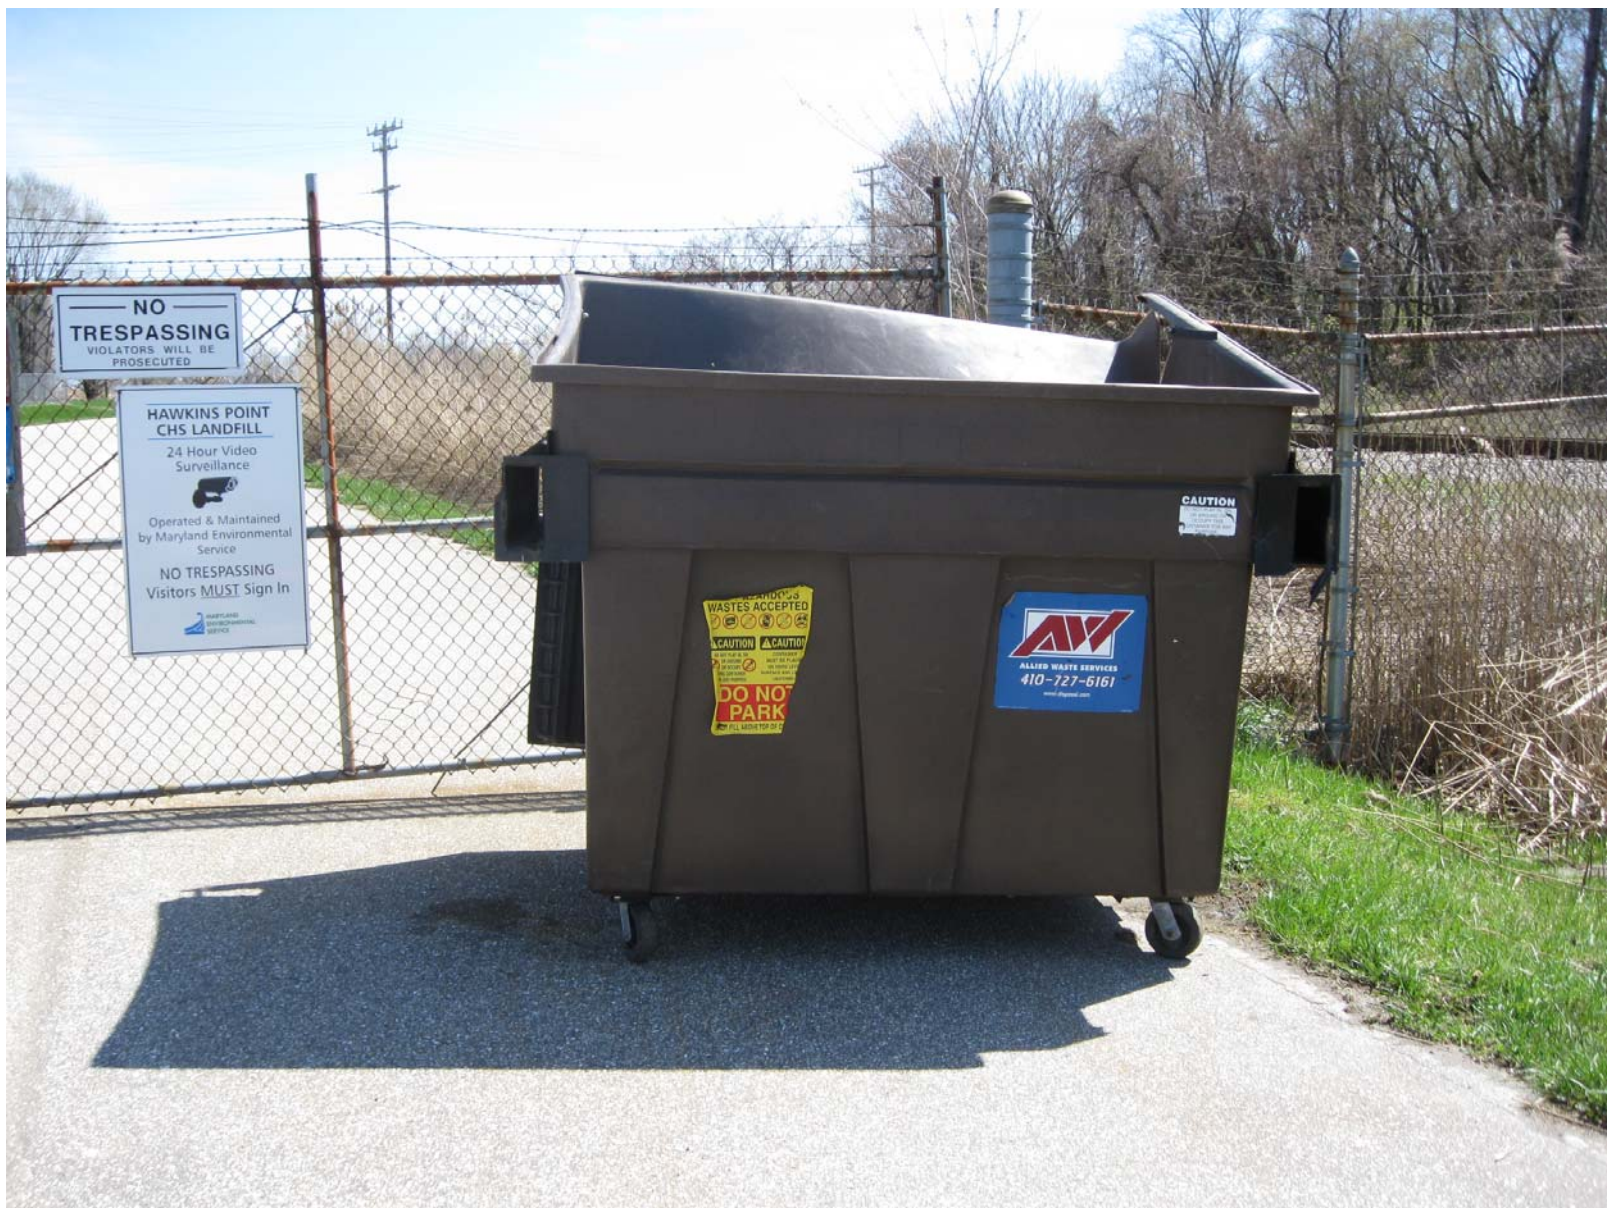
Photograph 9: SWMU No. 8 – Dumpster

The facility maintains a dumpster near the site entrance, as well as several garbage and recycling bins within the maintenance and office buildings. General office waste is deposited in the bins and solid waste dumpster, respectively. The dumpsters are emptied on a regular basis by a third party for off-site disposal at a permitted sanitary landfill. SWMU No. 8 is shown in Photograph 9 in Appendix A at the time of the 2010 RCRA Site Visit.

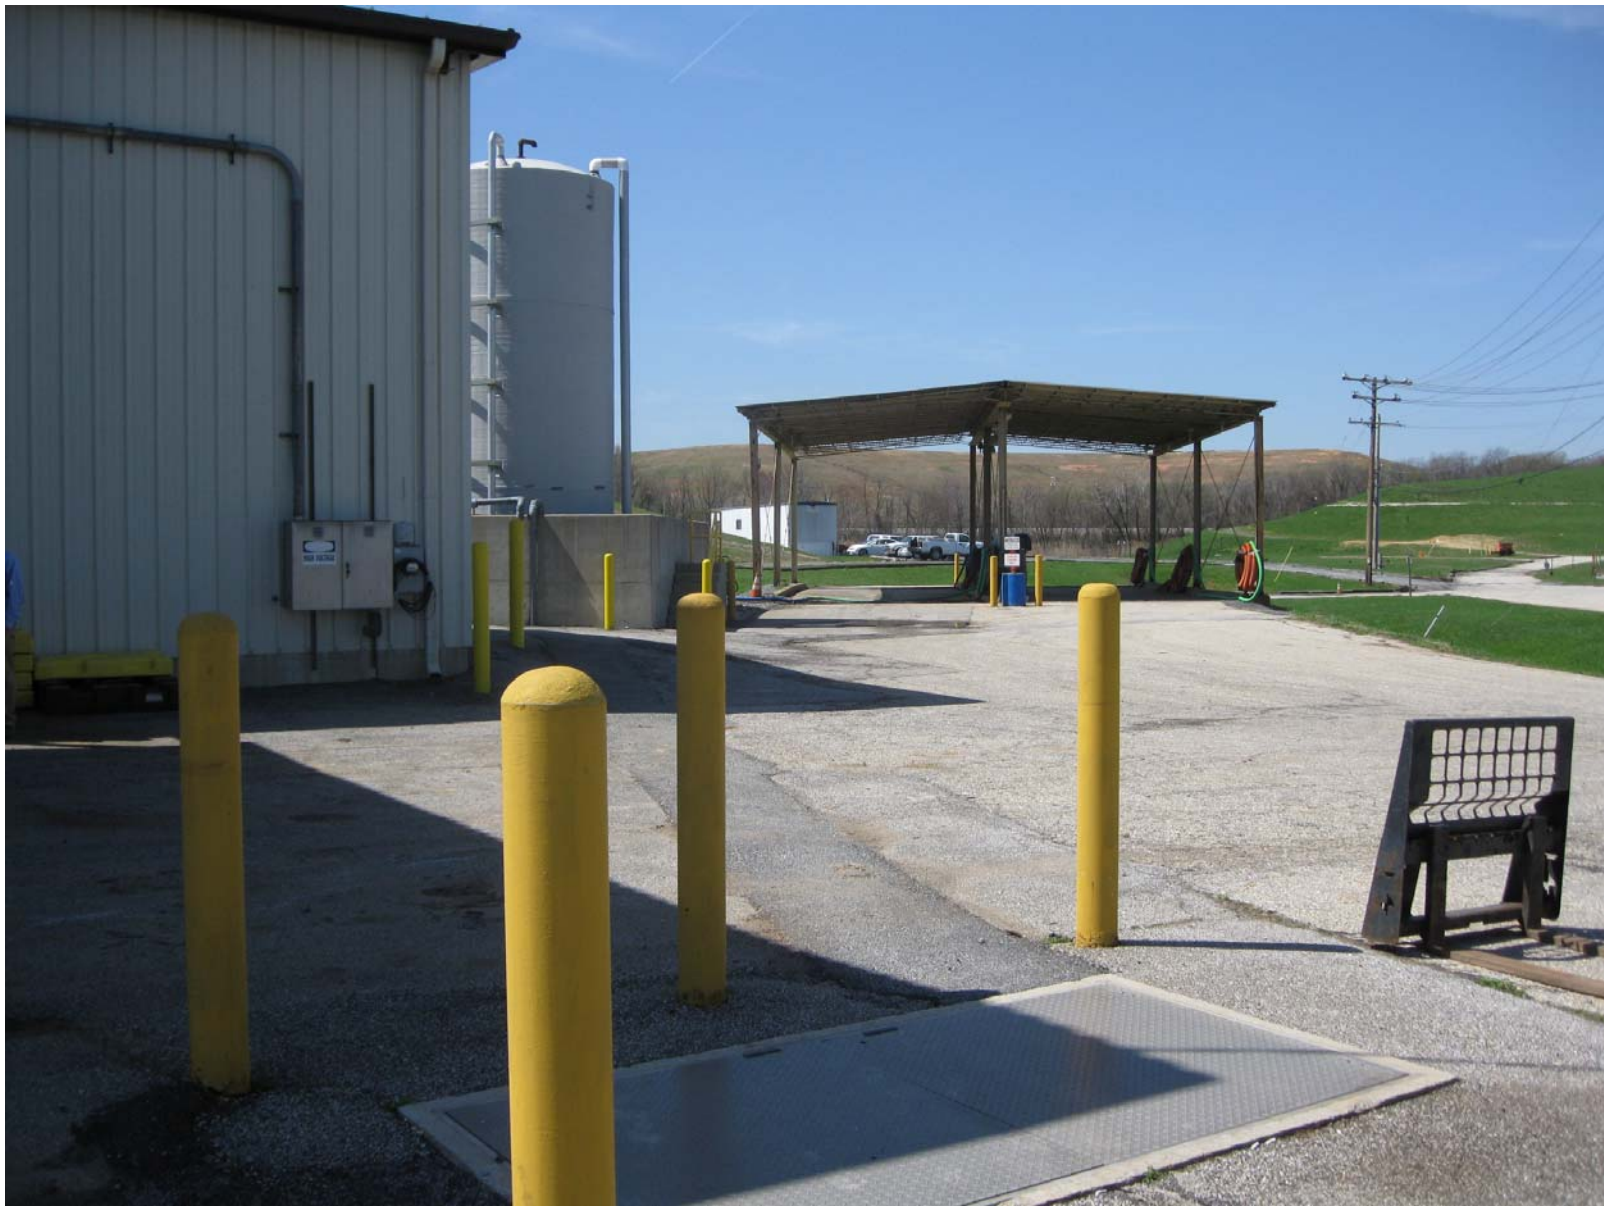
There are two separate collection systems that collect landfill leachate from the landfill cells. The first of these leachate collection systems serves Areas 2, and 3, while the second serves Area 5. The systems collect the leachate via below ground perforated leachate collection lines. The two separate leachate collection systems convey leachate via below ground lines to a single wet well, where the combined leachate flow is pumped to an aboveground storage tank with a capacity of 21,573 gallons.

This leachate collection system was rehabilitated in 2002, and requires routine maintenance consisting of cleaning of the leachate lines. SWMU No. 11 is shown in Photograph 10 in Appendix A at the time of the 2010 RCRA Site Visit.

In 2003, the valve box for the Leachate Collection System (SWMU No. 11), overfilled with water. The problem was resolved by removing the water and the valve box was modified to prevent subsequent overflows. AOC No. 2 is shown in Photograph 10 in Appendix A at the time of the 2010 RCRA Site Visit.

Photograph 10: SWMU No. 11 (foreground) – Leachate Management Area & Collection

AOC No. 2 (foreground) – Valve Box Overflow

SWMU No. 9 (left) – Plant Building/Warehouse

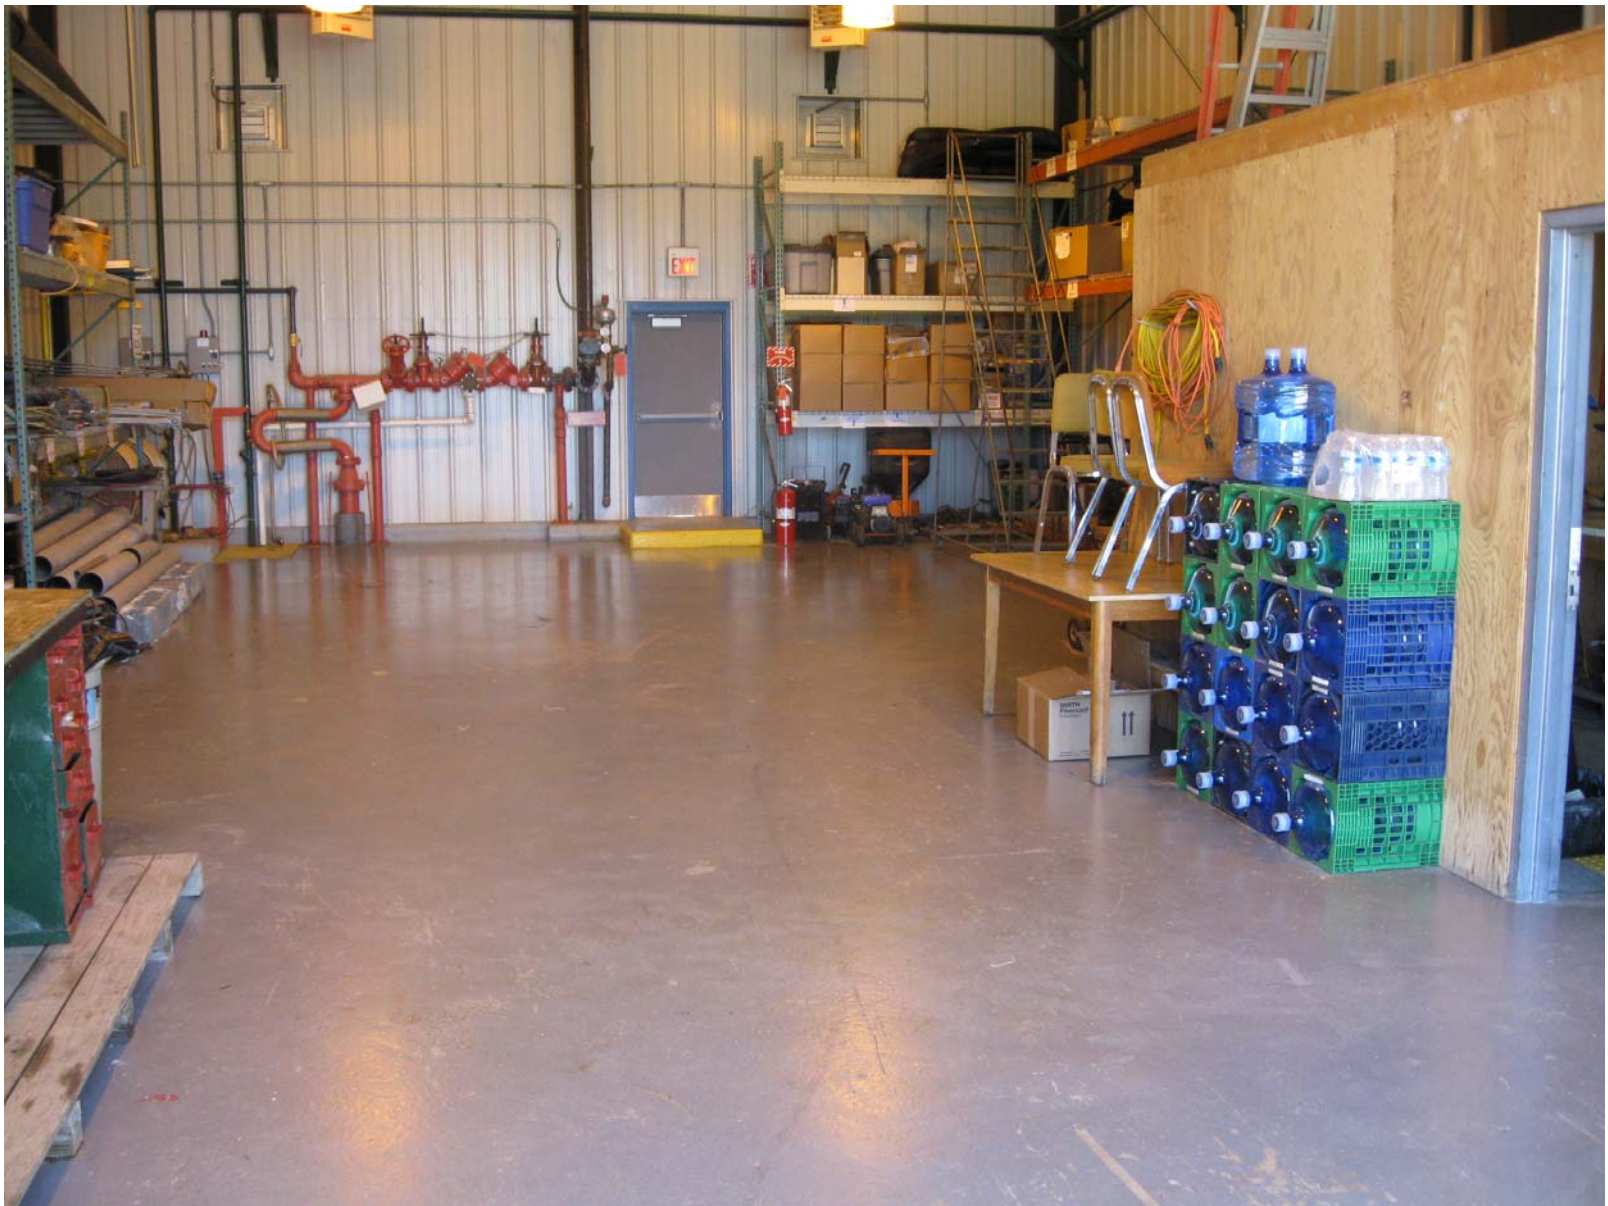
The onsite Plant Building/Warehouse was used previously to perform periodic maintenance on tractors, lawnmowers, backhoes, chainsaws, and various other pieces of equipment used to maintain the landfill site. In the past, a waste oil drum was kept on a containment pad for storage of waste oil drained during equipment maintenance. This maintenance is no longer performed on site, and a waste oil drum is no longer maintained at the site. The warehouse is currently only used for storage. SWMU No. 9 is shown in Photographs 10 and 11 in Appendix A at the time of the 2010 RCRA Site Visit.

In 2002, during the rehabilitation of the Leachate Collection System (SWMU No. 9), approximately 200 gallons of caustic soda was released within the on-site maintenance building. This spill occurred while approximately 1,500 gallons were being pumped into a tanker truck for offsite transport. AOC No. 1 is shown in Photograph 11 in Appendix A at the time of the 2010 RCRA Site Visit.

Photograph 11: SWMU No. 9 – Plant Building/Warehouse inside
AOC No. 1 – 2002 Caustic Soda Release

This spill resulted in a Notice of Violation, and was remediated under MDE supervision.
